WATER DAMAGE ASSESSMENT

123 Main Street
Lake Tahoe, CA/NV

At the request of the owner, Tahoe Mold and Water did a limited visual inspection of the water loss at the above referenced property originally on 4/27/15 at 8:00PM and later at 7:00 PM on 5/1/15. The purpose of this assessment is to give evidence to the extent of damage as a result of the water loss that occurred within the previous 2 weeks.

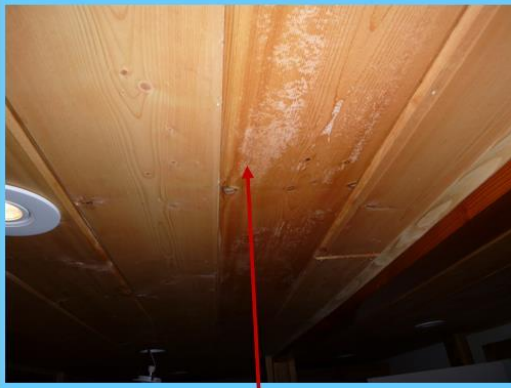
Bedroom 4

The ceiling has some cupping and nail bleeding. It appears to be drying well with just slightly elevated moisture in some areas. Inspection of the ceiling through the removed recessed light indicates that the ceiling does not have a drywall overlayment or insulation. Given this, the ceiling should dry well in place but may still have remaining signs of visible damage.

Visible damage to wood ceiling finish. Also some cupping and shifting of ceiling noted.

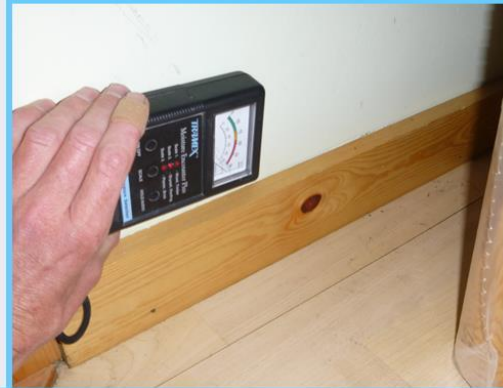
Bedroom 4

Moisture readings are over 30% with furniture, baseboard, drywall, and flooring remaining.

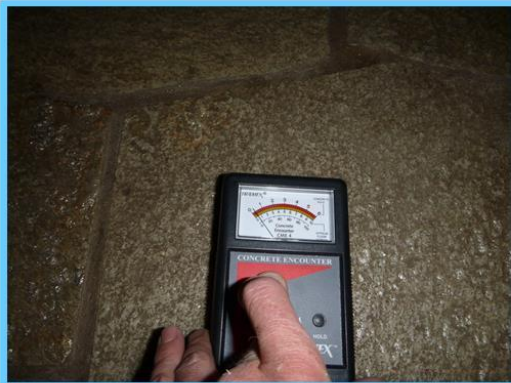
2nd Floor Hallway

Electronic non penetrating moisture reads about 2% at the unaffected entry taken from multiple readings.

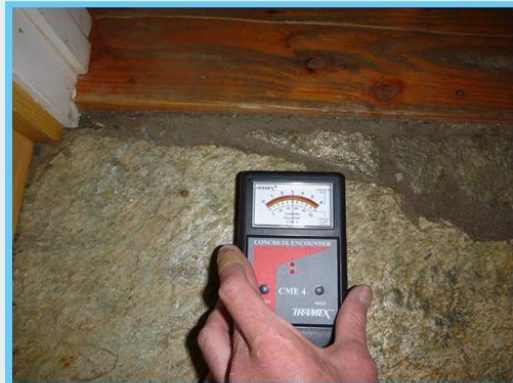
2nd Floor Hallway

Electronic non penetrating moisture reads about 30% at the area adjacent to bedroom 4 taken from multiple readings in the area.

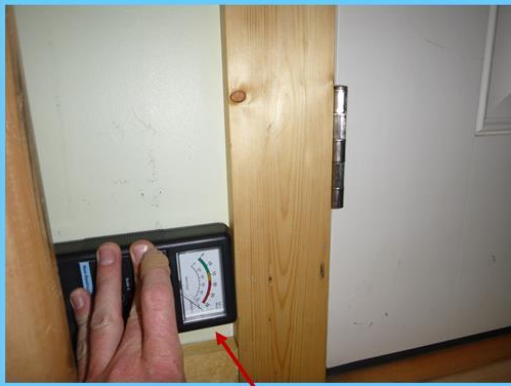
Bedroom 4

Drywall has elevated moisture content on the west and east walls with the south wall inaccessible for readings due to personal property. The west wall is currently marked with an X that likely indicates its planned removal. There is no indication of partial removal of the wall between bedroom 3 and bedroom 4. This wall should also be opened up and if any moisture is detected, the south wall as well.

Exterior West Wall has substantially elevated moisture requiring drywall and insulation removal. Trim and baseboard was be removed as well.

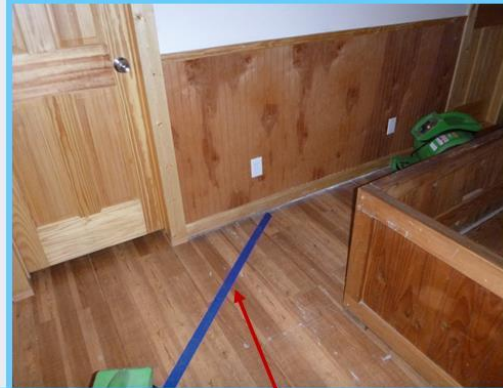
Lower Den

Contractor provided blue tape to delineate travel of water.

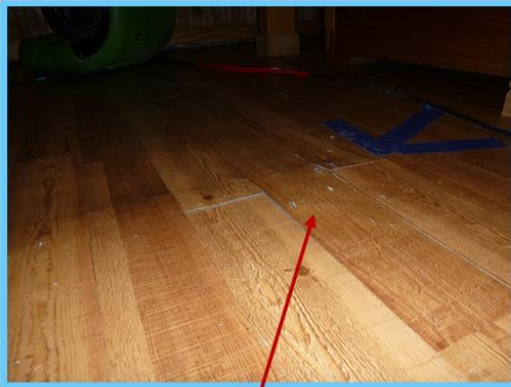
Lower Level Den

The lowest level had puddling in low points of the floor upon the first visit. On the second visit the water had been extracted and the vinyl floor remains in place. The floor has visible damage indicated by an Arrow provided by the contractor. Regardless of this small damage, it is recommended that the floor be removed to expose the wet concrete slab below. Without access to the slab, moisture content readings can't be taken unless through holes to be drilled in the floor to allow for destructive testing of the concrete. In addition, concrete slabs can be difficult to dry, especially when encapsulated in vinyl flooring. This makes focusing air movement to stimulate evaporation near impossible. If the pool table can't be removed soon, it is recommended that the floor be cut around it to get air movement stimulation as soon as possible. The contractor should assess the subfloor using an ASTM approved concrete moisture measurement protocol until all concrete is within 5% of the dry norm.

Visible bubbling and cracking of vinyl plank flooring.

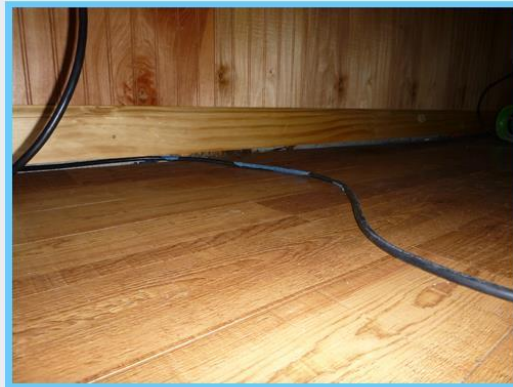
Lower Level Den

The wall system and cabinets were constructed in a manner to be protected from ground moisture. They are all set off the floor with a cavity below and behind them. Given this fact it does not appear necessary to tear out any wall surfaces or cabinetry to allow for wall drying. Currently the contractor has air movers pointed into these wall cavities to stimulate drying. Readings of walls were slightly elevated though much less then on our initial visit.

Wall and cabinets installed with gap between them and the flooring. This allows for materials to be less water effected then in typical construction and allows for drying in place.
