WATER DAMAGE ASSESSMENT

123 Main Street
Lake Tahoe, CA/NV

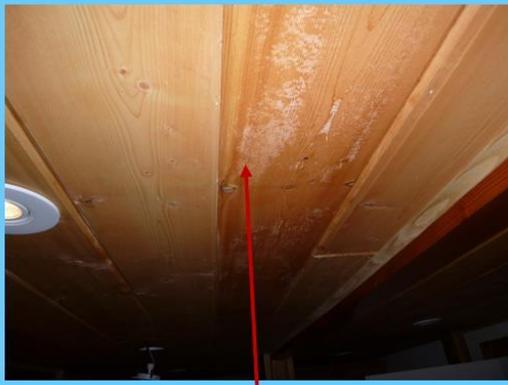
Bedroom 4

The ceiling has some cupping and nail bleeding. It appears to be drying well with just slightly elevated moisture in some areas. Inspection of the ceiling through the removed recessed light indicates that the ceiling does not have a drywall overlayment or insulation. Given this, the ceiling should dry well in place but may still have remaining signs of visible damage.

Visible damage to wood ceiling finish. Also some cupping and shifting of ceiling noted.

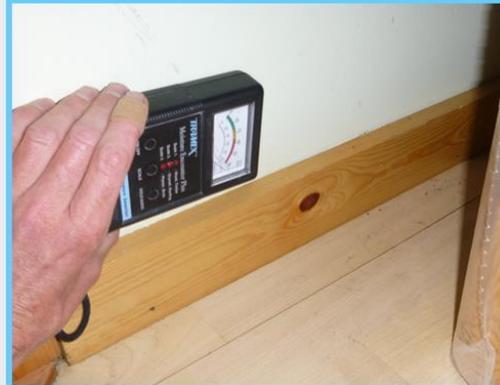
Bedroom 4

Moisture readings are over 30% with furniture, baseboard, drywall, and flooring remaining.

- Run a dehumidifier substantiated by AHAM calculations of the loss to run during demolition and drying procedure
- Move furniture off floor and separate damaged furniture from unaffected furniture.
- Remove all baseboard in water travel areas
- Remove Laminate Floor and underlayment and dispose.
- Remove drywall from west exterior wall
- Flood cut east wall 2' up and cut to south exterior wall if moisture is detected in this wall.
- Continue air movement directed at sub-floor, open wall cavities, and any areas of the ceiling that are above 12% moisture content
 - Ceiling should later be inspected to determine if replacement is necessary.
 - Nail staining and gaps left from cupping may be unable to be repaired.

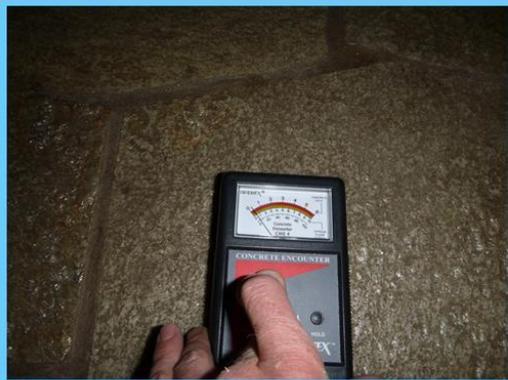
2nd Floor Hallway

Electronic non penetrating moisture reads about 2% at the unaffected entry taken from multiple readings.

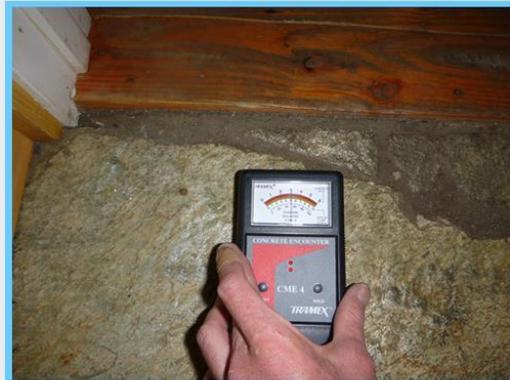
2nd Floor Hallway

The mitigation contractor has provided a blue tape line to delineate the water travel as a result of the loss. The inspector agrees with the contractor's water travel indications. The contractor and inspector agree that a portion of the stone hallway has elevated moisture and will need to be dried. It is always more difficult to promote evaporation of subfloor and framing moisture when there is a sealed finished floor installed over it. In this case there is quartzite flag stone with a sealer present. If air movement can be promoted over the stone it is possible that this can be dried without removal. If drying is substantially inhibited, either air movement will need to be provided to the subfloor from below or removal of flooring and drying from above will be necessary.

Electronic non penetrating moisture reads about 30% at the area adjacent to bedroom 4 taken from multiple readings in the area.

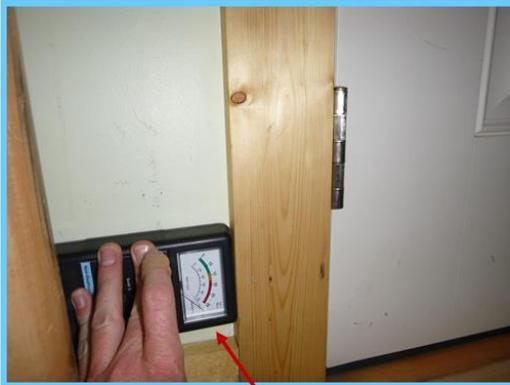
Bedroom 4

Drywall has elevated moisture content on the west and east walls with the south wall inaccessible for readings due to personal property. The west wall is currently marked with an X that likely indicates its planned removal. There is no indication of partial removal of the wall between bedroom 3 and bedroom 4. This wall should also be opened up and if any moisture is detected, the south wall as well.

Exterior West Wall has substantially elevated moisture requiring drywall and insulation removal. Trim and baseboard was removed as well.

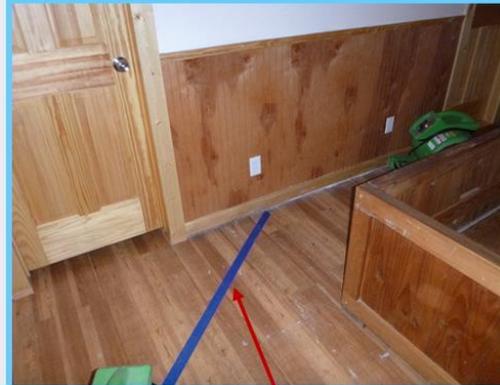
Lower Den

Contractor provided blue tape to delineate travel of water.

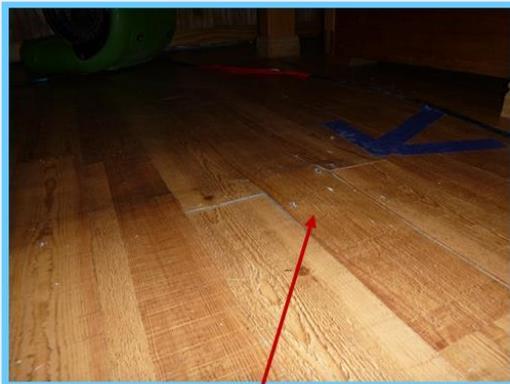
Lower Level Den

The lowest level had puddling in low points of the floor upon the first visit. On the second visit the water had been extracted and the vinyl floor remains in place. The floor has visible damage indicated by an Arrow provided by the contractor. Regardless of this small damage, it is recommended that the floor be removed to expose the wet concrete slab below. Without access to the slab, moisture content readings can't be taken unless through holes to be drilled in the floor to allow for destructive testing of the concrete. In addition, concrete slabs can be difficult to dry, especially when encapsulated in vinyl flooring. This makes focusing air movement to stimulate evaporation near impossible. If the pool table can't be removed soon, it is recommended that the floor be cut around it to get air movement stimulation as soon as possible. The contractor should assess the subfloor using an ASTM approved concrete moisture measurement protocol until all concrete is within 5% of the dry norm.

Visible bubbling and cracking of vinyl plank flooring.

- Install air movers directed at wet areas of concrete slab
 - If drying is slow it may be necessary to
 - tent the floor and duct a dehumidifiers exhaust under the tent
 - Continue drying until concrete materials are within 5% of dry norm using an approved method for concrete moisture readings.
- Continue air movers directed under wall cavities until construction materials are below 12%
- Remove T&G ceiling and suspected drywall above
 - Remove any wet insulation (if present) in ceiling cavity
 - Direct air movers at wet framing and ceiling
- Condition of ceiling light fixtures is in question and replacement is prudent to prevent sudden failure.

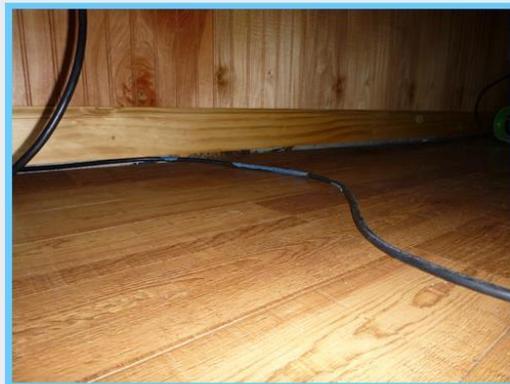
Lower Level Den

The wall system and cabinets were constructed in a manner to be protected from ground moisture. They are all set off the floor with a cavity below and behind them. Given this fact it does not appear necessary to tear out any wall surfaces or cabinetry to allow for wall drying. Currently the contractor has air movers pointed into these wall cavities to stimulate drying. Readings of walls were slightly elevated though much less then on our initial visit.

Wall and cabinets installed with gap between them and the flooring. This allows for materials to be less water effected then in typical construction and allows for drying in place.
