5/18/18

MOLD INSPECTION REPORT

*123 Main St.
Tahoe*

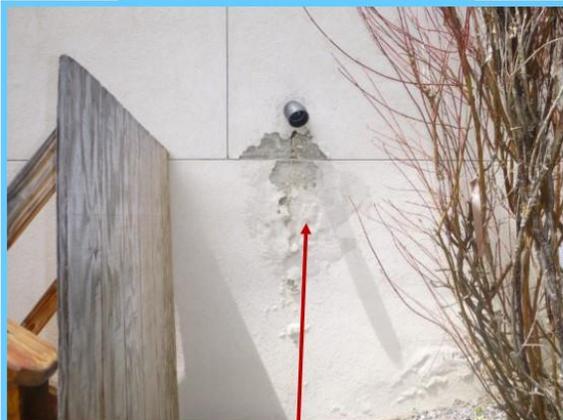
Exterior

The property is a three level home with a detached garage. The detached garage has living space on the second floor. The property is a down sloping lot. The structures have stucco surface material on the exterior. There is minor deterioration and spalling of this surface on the northeast side of the main structure. This appears to be from condensation around the furnace exhaust line.

Moisture damage and spalling on stucco under furnace exhaust on northeast side of the main house.

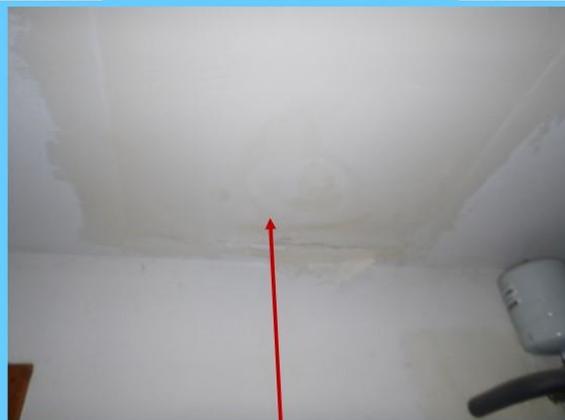
Garage

Moisture damage to gypsum board ceiling surface in the south corner of the garage. This is under the bathroom, so may be the result of leaky plumbing or water intrusion from the adjacent deck. The area was dry at the time of the inspection.

Moisture damage to ceiling at south corner under bathroom.

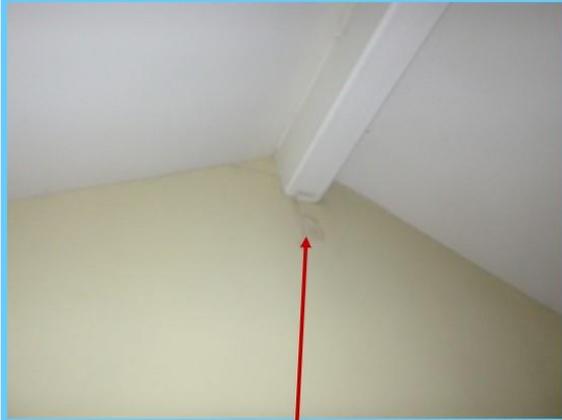
Garage Suite

Staining is present around the ridge beam ends. This appears to be from a metal beam hanging creating condensation.

Moisture damage to wall surface over ridge beam hanger.

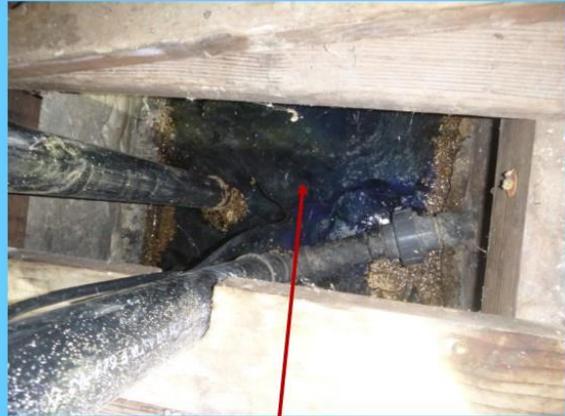
Utility Room

Standing water is present in the pit under the wood decking. The water appears to be contaminated in nature, due to its oily appearance.

Contaminated water in pit.

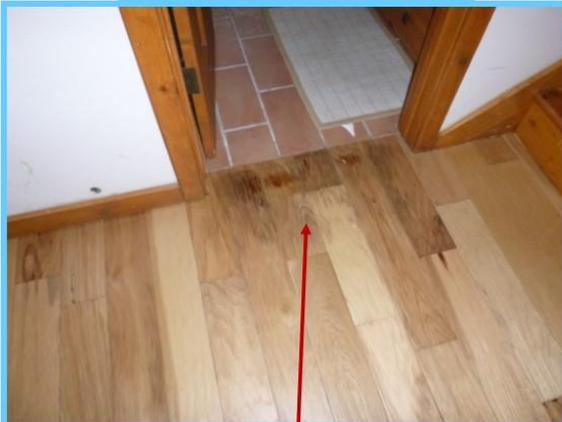
Lower Hall

Moisture stains are present on the wood floor. This is installed over a slab foundation. The floor had elevated moisture in the areas around the staining. This is likely from ground moisture wetting the slab subfloor.

Water staining on wood floor.

- Detach and remove baseboard trim to allow for floor removal. Inspect lower wall surfaces to determine if mold damage is present.
- Tear out and bag and dispose of wood floor where impacted by moisture. ***This may require removal of all wood flooring on the first floor.***

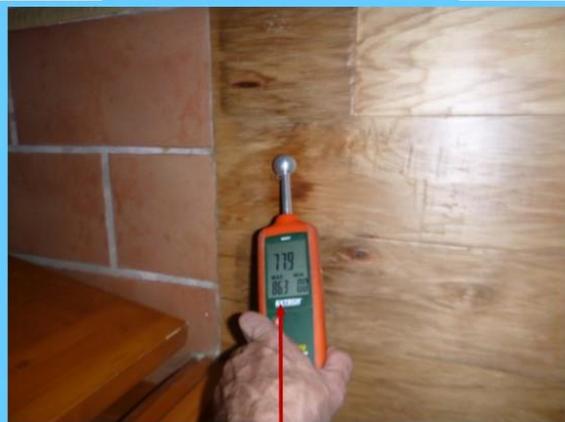
Lower Hall

Elevated moisture in flooring.

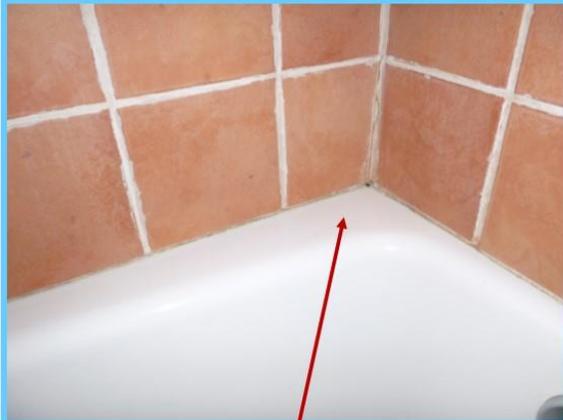
Lower Bathroom

Missing/ damaged grout is present on the shower walls around the bath tub. This condition can allow moisture to impact the wall substrate and should be repaired.

Missing/cracked grout.

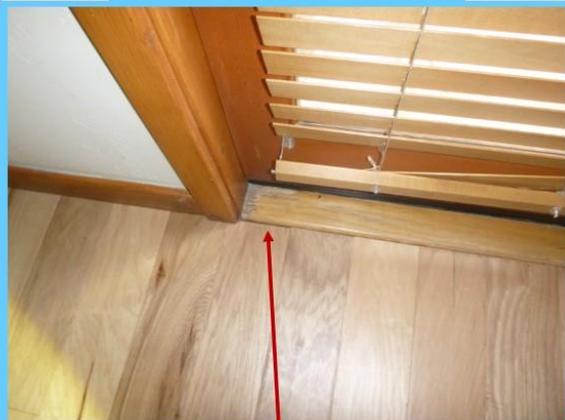
Lower Bedroom

Minor moisture damage is present on the door threshold adjacent to the exterior door. The flooring was dry at the time of the inspection.

Minor moisture staining/damage around the door threshold.

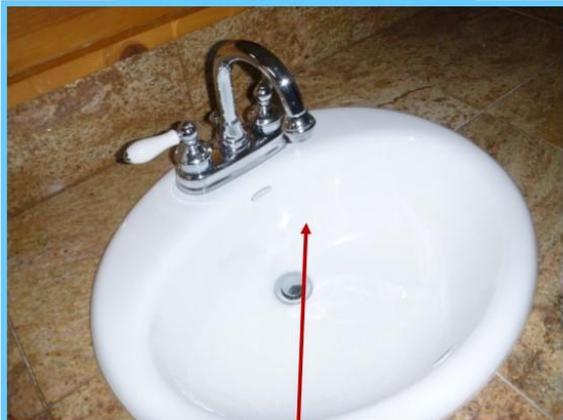
Lower Bathroom

Faucet is dripping.

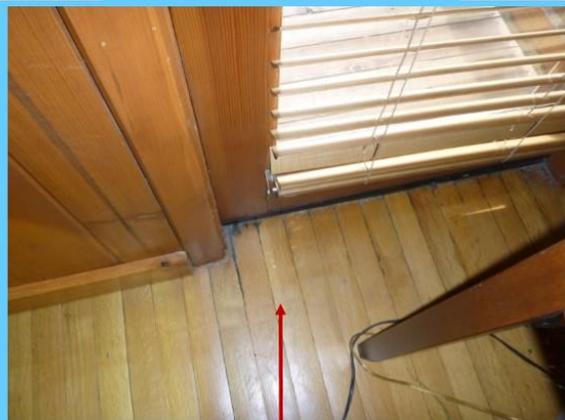
Minor moisture damage is present on the wood floor adjacent to the exterior door. The flooring was dry at the time of the inspection.

The Office floor surface sample demonstrated sparse Cladosporium growth. This is consistent with atypical mold growth, remediation is recommended.

Moisture damage to wood floor by the exterior door.

- Remove all personal property.
- Isolate work area under negative pressure with containment door set at doorway.
- Cut, bag and dispose of impacted wood flooring.
- Structurally clean wood framing with mold present. HEPA vacuum and damp wipe all surfaces.
- Run air scrubbers to remove mold spores from air in work area for 24 hours
- Pass clearance inspection to be provided by a 3rd party Independent Environmental Professional.

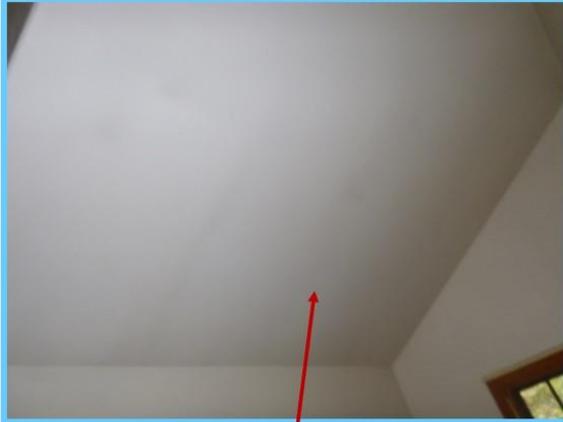
Hallway- 3rd Floor

Discoloration is present on the ceiling running in straight lines from the rafter framing on the backside of the wall. This can be the result of dirt sticking to wet surfaces. Often this damage represents a roof system with excessive moisture, likely from inadequate ventilation. Additional investigation is recommended.

*Discoloration of ceiling where roof framing exists.
(typically an indication of elevated moisture)*

- Create 4” holes to gain access to at least three areas of the ceiling for further evaluation.

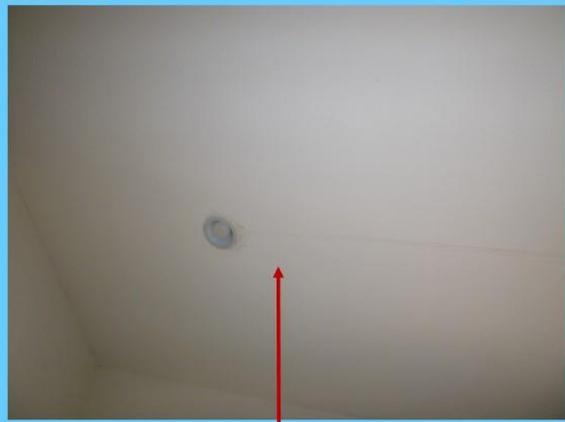
SW Bedroom-3rd Floor

Water staining is present on the ceiling around the recessed light fixture. This appears to be from excessive levels of water vapor in the roof cavity.

Moisture stains from around light fixture.

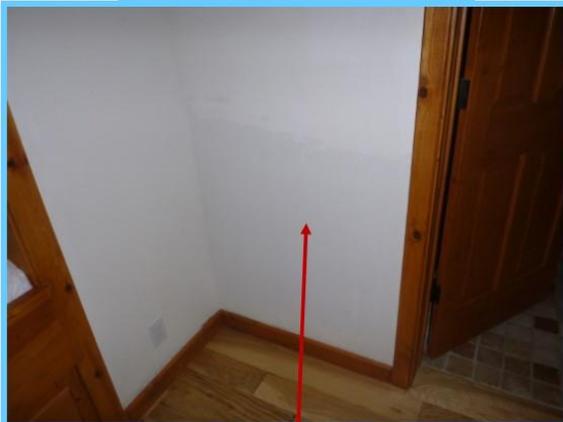
SE Bedroom-3rd Floor

A previous drywall repair was made to the wall on the backside of the bathroom plumbing wall. This is likely from a past leak. The area was dry at the time of the inspection.

*Previous drywall patch on backside of bathroom
plumbing wall.*

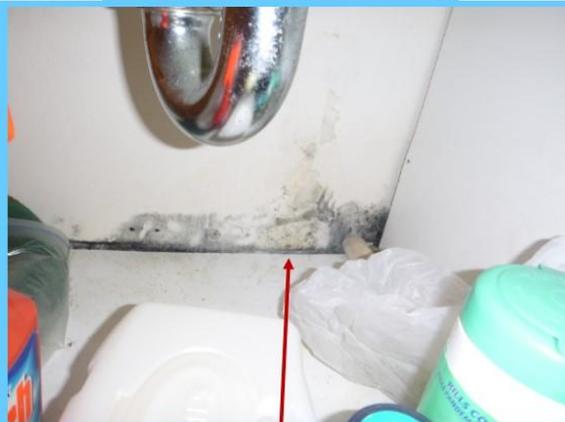
Master Bedroom

Atypical mold is present on the gypsum board wall surface behind the cavity cabinets. The area was dry at the time of the inspection.

The Master Bathroom wall surface sample demonstrated nearly confluent *Stachybotrys* “black mold” and moderate *Penicillium/Aspergillus* growth. This is consistent with atypical mold growth, remediation is recommended.

*Atypical mold on gypsum board behind vanity cabi-
net.*

- Remove all personal property. Wipe all hard objects and hepa vacuum porous items prior to storing outside of the work area.
- Isolate entire bathroom under negative pressure with containment door set at doorway.
- Detach and remove vanity cabinets.
- Cut, bag, and dispose of drywall a minimum of 2’ beyond visible water damage. Drywall is typically cut at 2’ or 4’ from the floor with upper drywall remaining.
- Remove and bag insulation in open wall/ceiling cavities
- Structurally clean wood framing with mold present.
- HEPA vacuum and damp wipe all surfaces.
- Run air scrubbers to remove mold spores from air in work area for 24 hours
- Pass clearance inspection to be provided by a 3rd party Independent Environmental Professional.

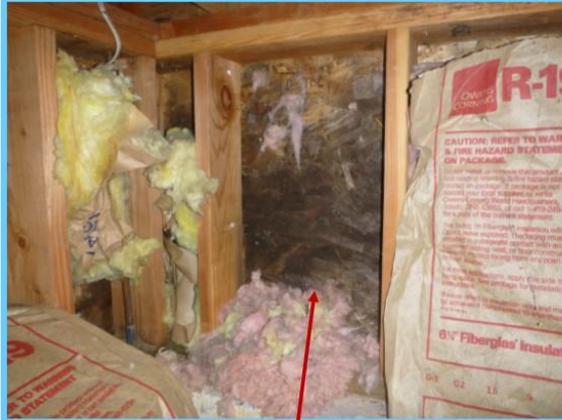
Atypical mold is found on the perimeter wall sheathing as well as some of the floor joists. The perimeter wall has slightly elevated moisture levels. Portions of the crawlspace are inaccessible due to the framed wood platform.

The Crawlspace perimeter wall surface sample demonstrated extensive Cladosporium growth. This is consistent with atypical mold growth, remediation is recommended.

Atypical mold on the perimeter wall.

- Isolate work areas under negative pressure using 6 mil containment walls
- Create a clean room constructed of plastic to provide access to the crawlspace area
- Remove wood platform where it obstructs access to the crawlspace areas
- Clean soil surface free of debris, and materials
- Install a permanent 6 mill moisture barrier. This will be simple plastic and not sealed to perimeter foundations. ***Upgraded barriers available.***
- Remove, bag and dispose of all insulation
- Structurally clean wood framing with mold present.
- HEPA vacuum and damp wipe all surfaces.
- Run air scrubbers to remove mold spores from air in work area for 24 hours
- Pass clearance inspection to be provided by a 3rd party Independent Environmental Professional.

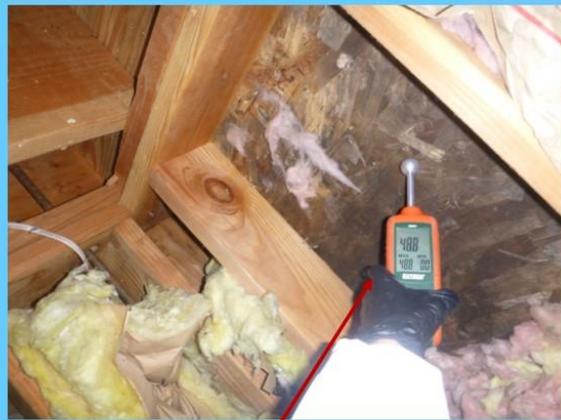
Crawlspace

Slightly elevated moisture.

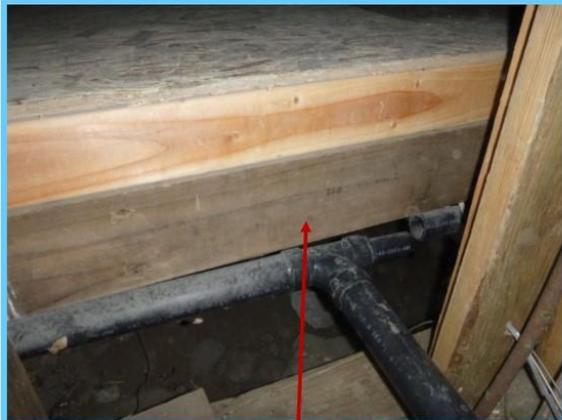
Crawlspace

Framed platform obstructs access to entire crawlspace.

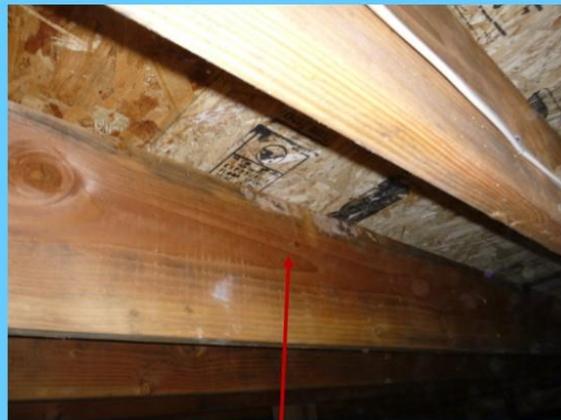
The Crawlspace floor joist surface sample demonstrated extensive Ophiostoma/Ceratocystis and limited Gonatobotryum growth. These are common lumber mold and does not typically indicate a mold issue.

Atypical mold on floor joist.
