Dollar Point Custom

East Shore Estate

Squaw Valley Contemporary

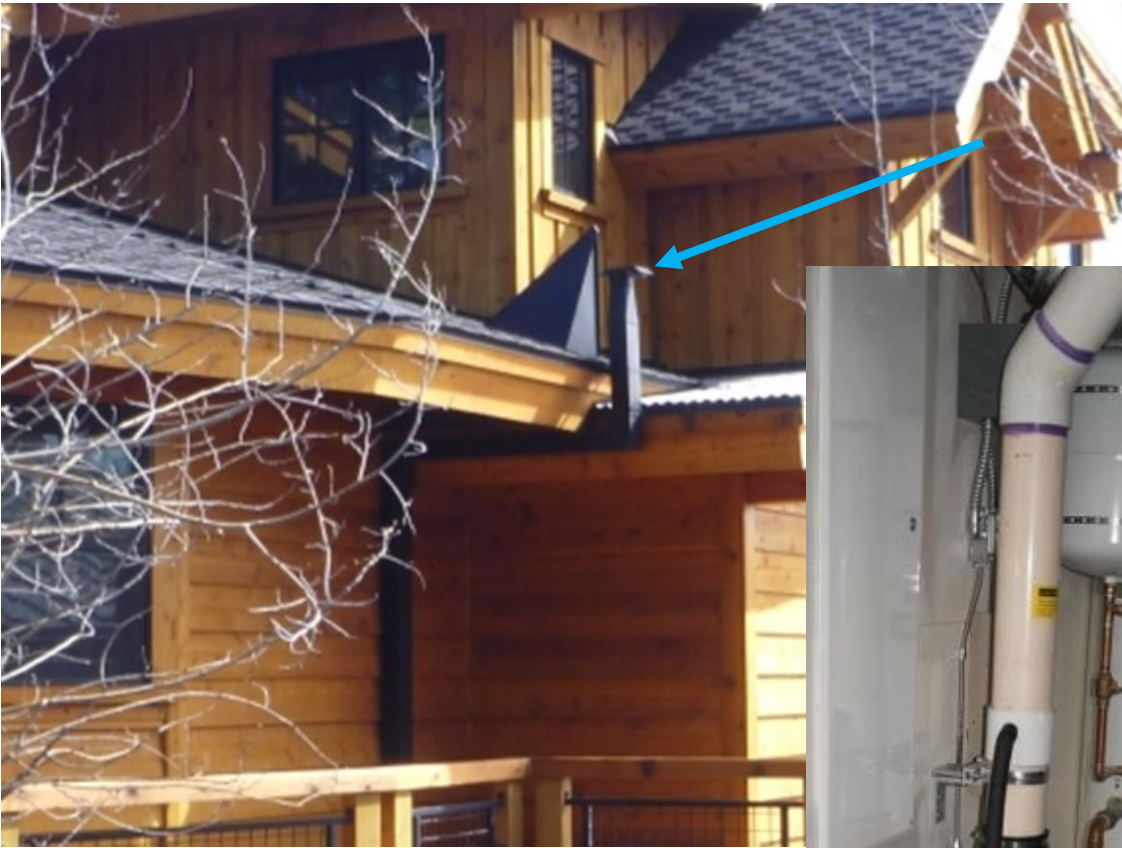
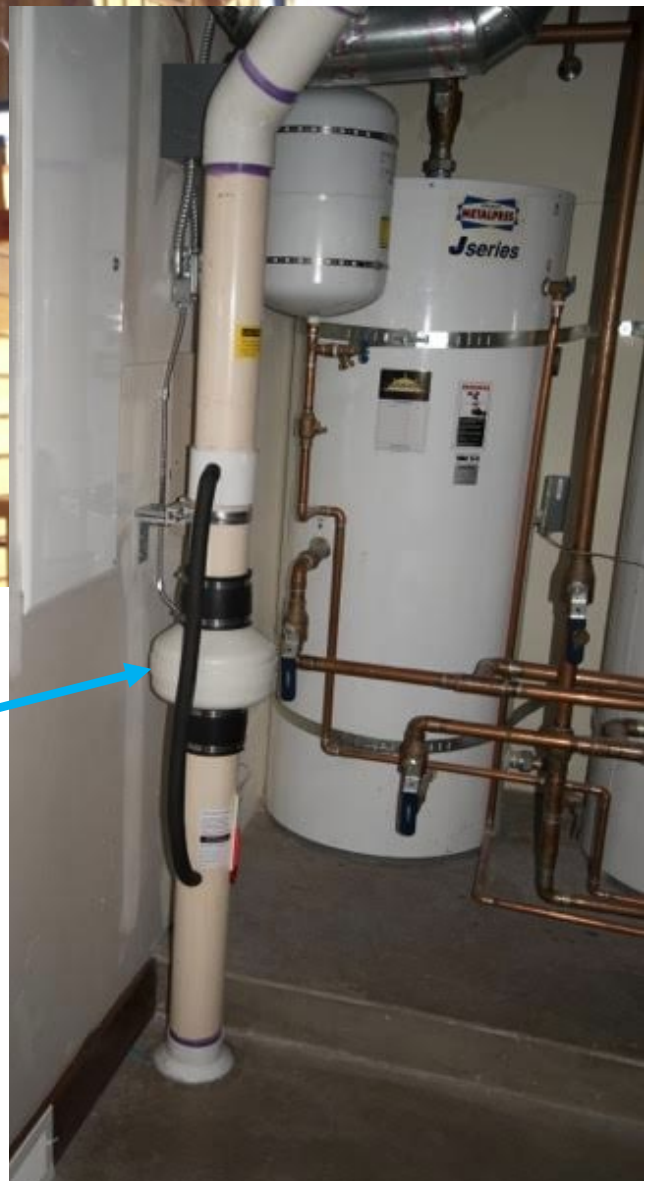
The layout of the home did not allow for the radon vent pipe to be run inconspicuously through interior walls and ceiling cavities. As a high value lake view home, the customer selected an option to disguise the exterior venting. This was run in custom black gutter pipe and exhausted through a protected cap. A snow diverter was installed above to ensure the system would not be damaged by snow shedding.

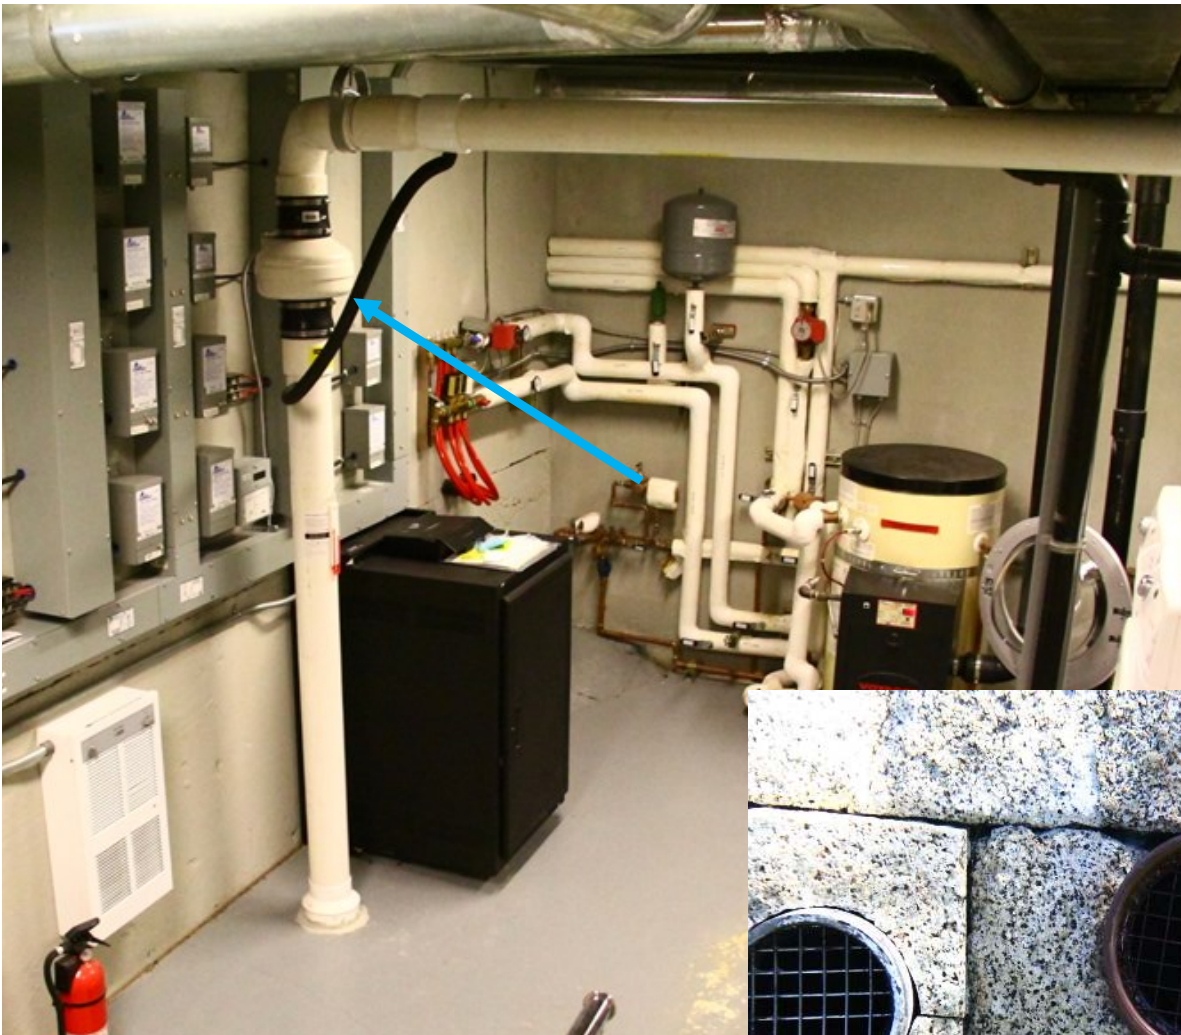
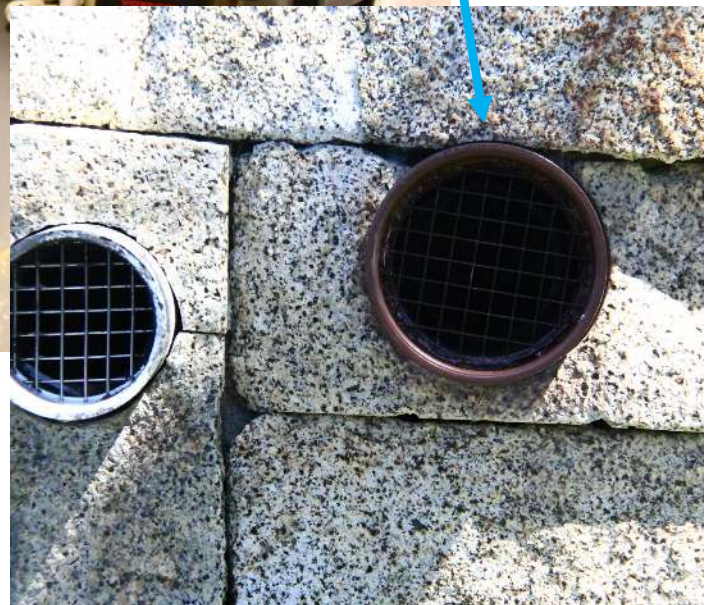
An incredible property with a significant radon issue in the boat house. Initial test showed averages over 20 picocuries. Our system included a suction pit and fan unit installed in the mechanical room. All venting run in 4" PVC to reduce system noise and hung with commercial grade hangers. Moisture protection, as always was provide for the fan. The vent line penetrates the exterior stonework through a clean core hole. All exterior plumbing is always painted, kept inconspicuous, and always protected from the elements and rodent entry.

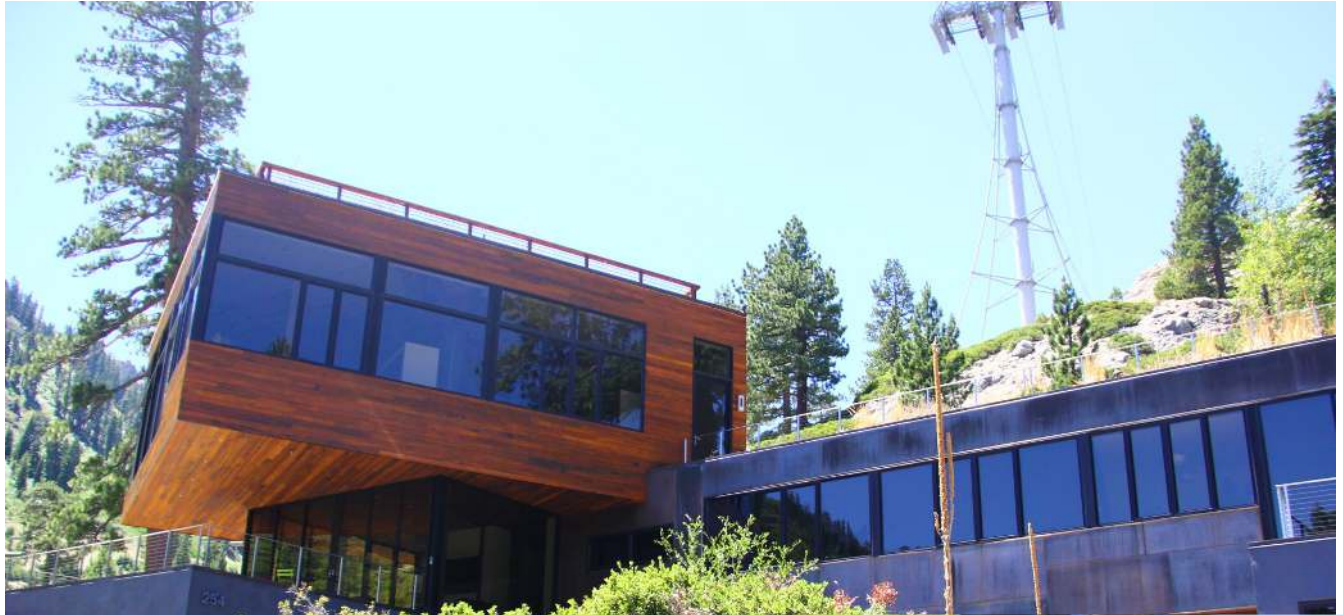
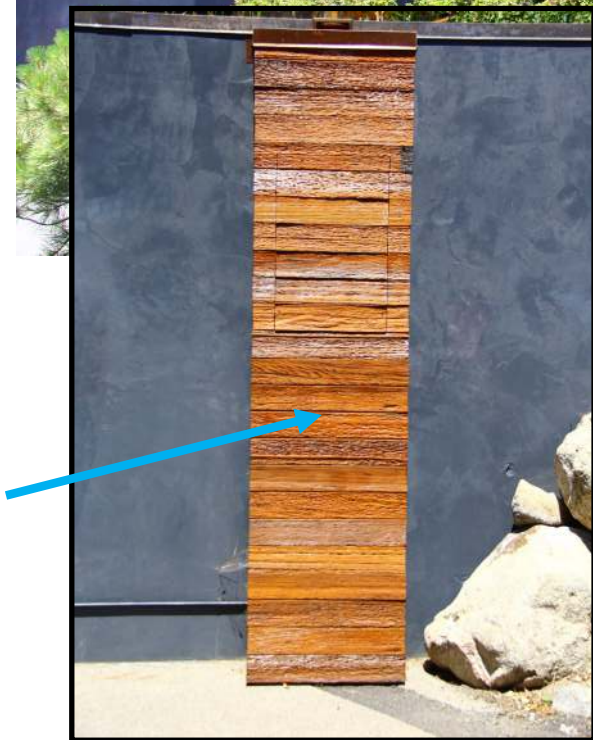
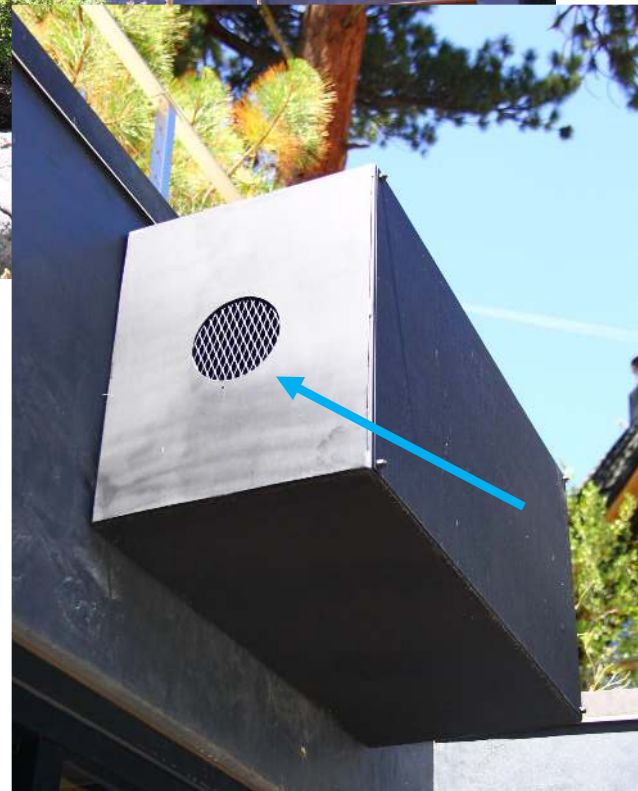
Given the rocky hillside the home was built into, a typical sub-slab system would not be fully effective. This system included two sub-slab suction pits, and a depressurization system on the perimeter drainage. In total, it required three fans units, including one high volume fan. All fan units and vent exhaust are hidden in enclosures consistent with the design and materials used for the home.
